## The Role of Backside Wear in Osteolysis

Gerard A. Engh M.D.  
Anderson Orthopaedic Research  
Institute  
Alexandria, Virginia

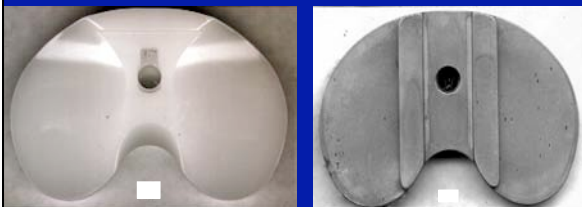
### Articular Side Pristine and Baseplate Worn

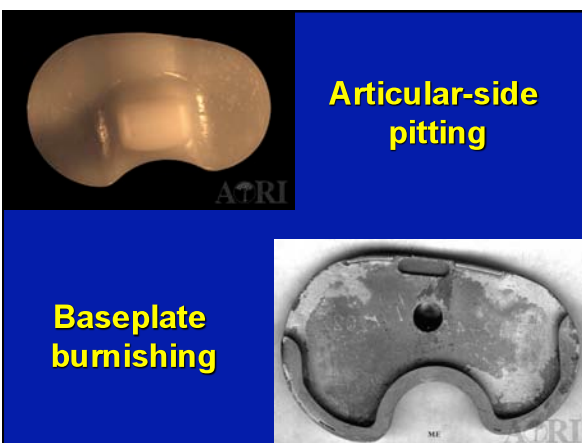
- 69 year old nun
- TKA *in situ* 3.5 years

### Articular-side pitting

### Baseplate burnishing

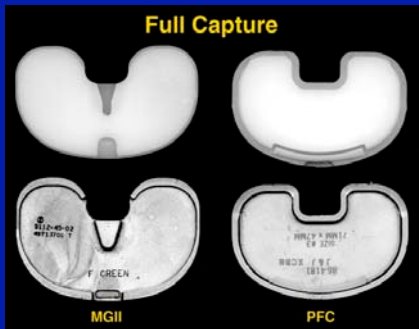
### Snap Fit

#### Full Capture

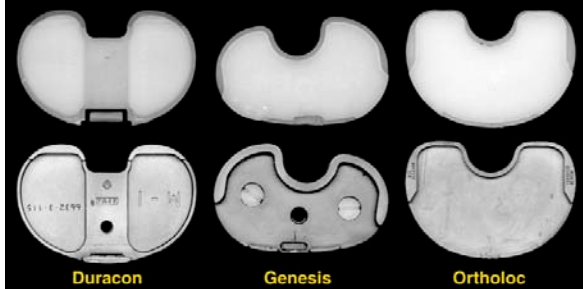
### Snap Fit

#### Partial Capture

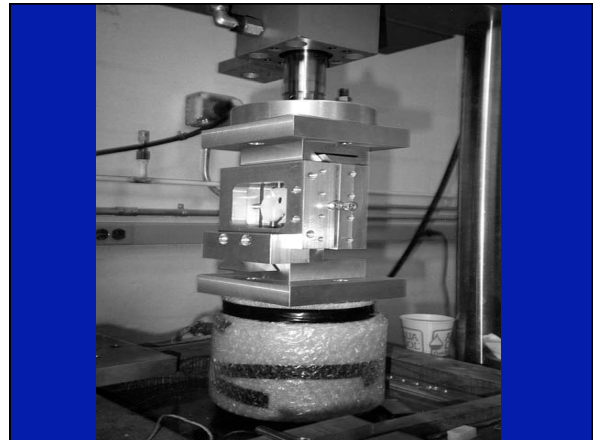
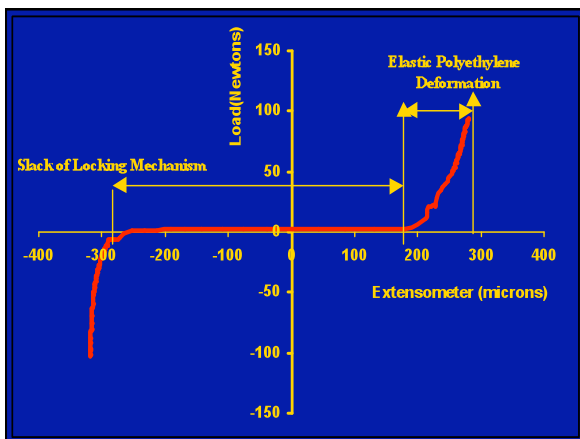
## Mechanical Testing Protocol

- Mount tray in acrylic
- Precondition: 37° water bath for 2 weeks
- Clamp components in 2 individual frames
- Measure motion before resistance is encountered

- All implants out of the box had a mean 90 microns of motion
- Wide variation within any implant type
- Wide range of motion for all implants

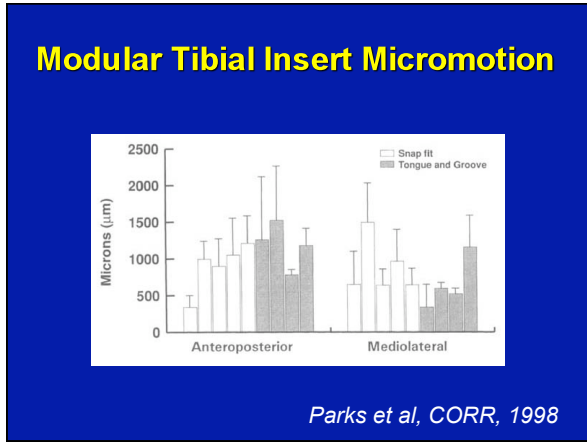
## Study Group (N=29)

- 12 Postmortem implants  
(2 snap-fit, 10 tongue-in-groove)
- 17 Components from revision surgery  
(9 snap-fit, 8 tongue-in-groove)
