Complex Tibia Plateau Fracture

Andre Yanuar

M, 53 years old, MVA 11-11-2021

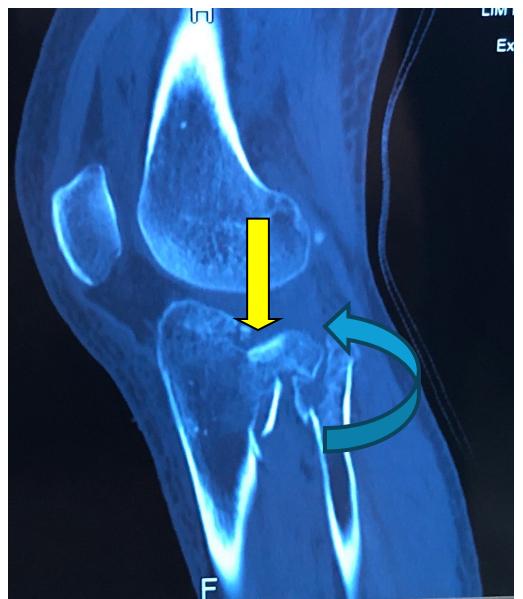
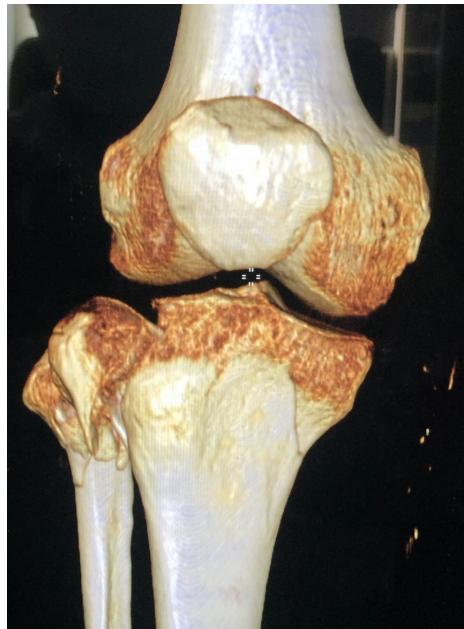
Mechanism of Injury

Flexion - Valgus

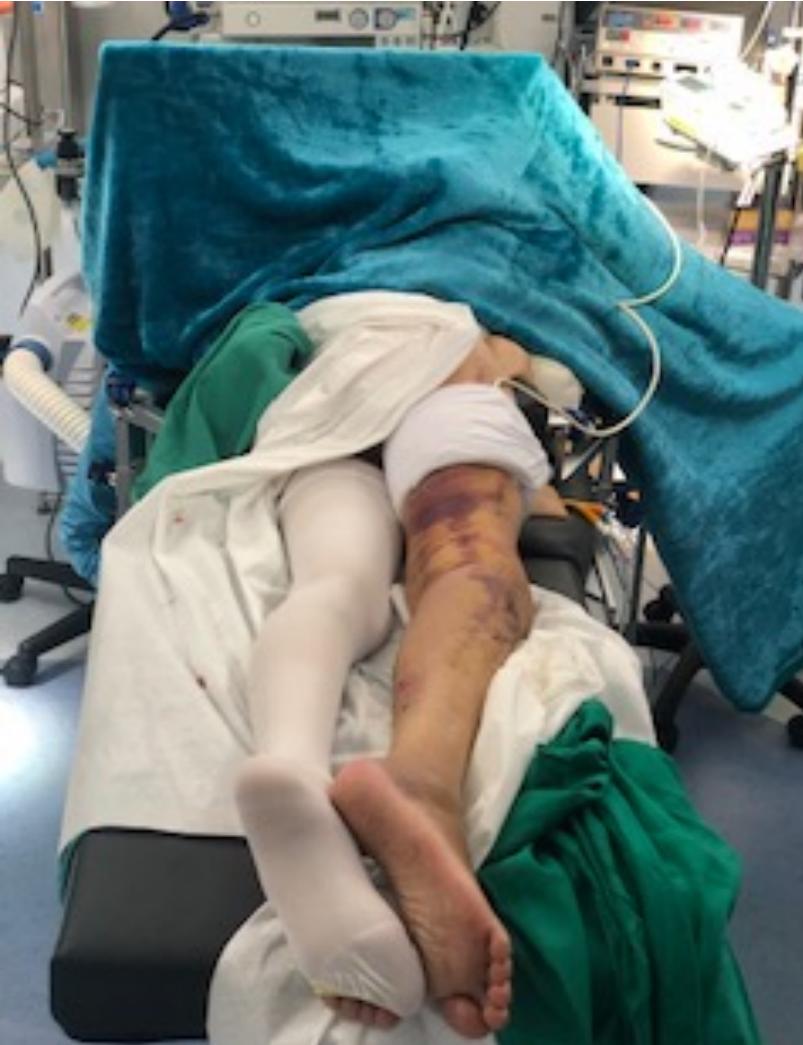
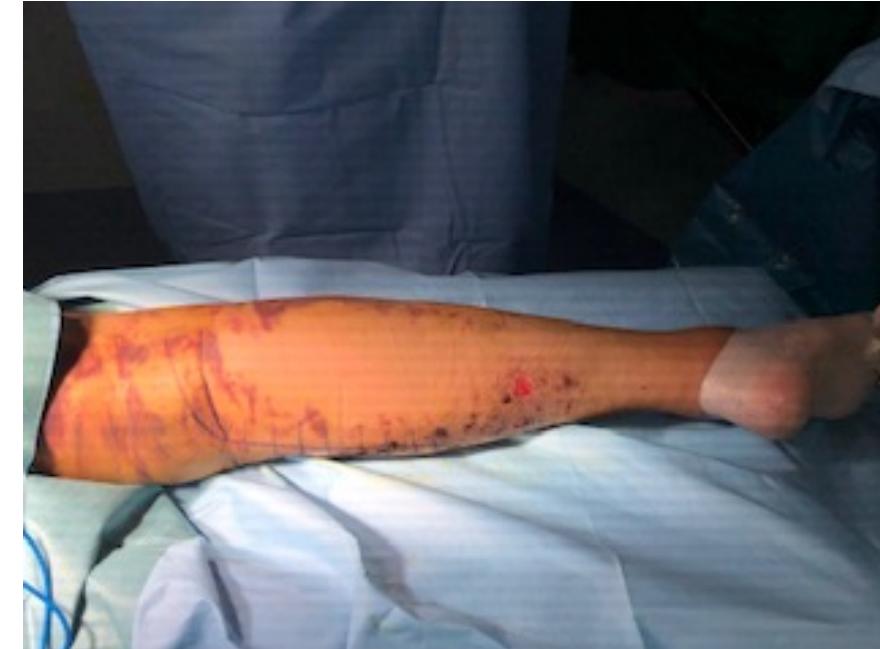
Reversed L – Shaped incision

Reversed L – Shaped incision

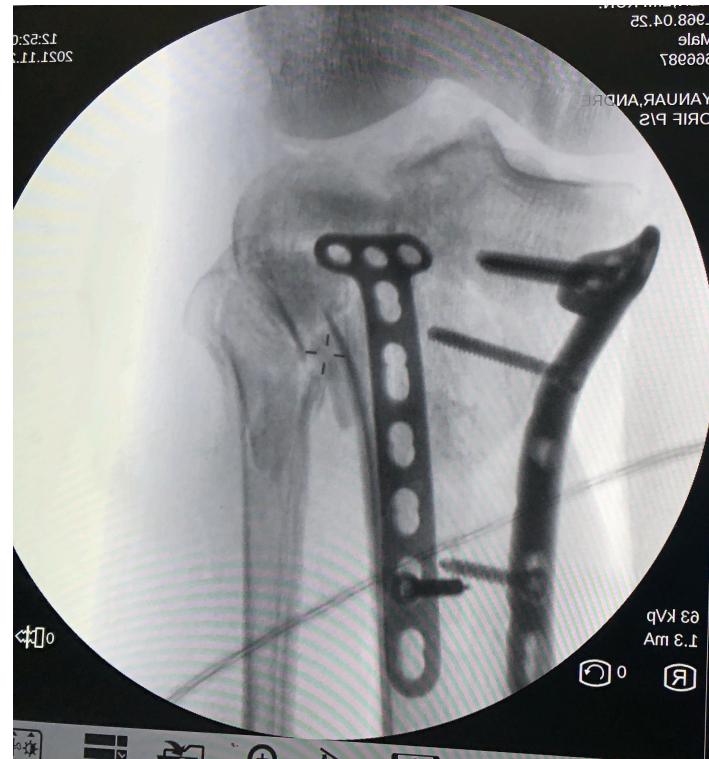
Supporting implant
